Lake Minnewaska Phase 1 Resource Investigation

Project title: Lake Minnewaska Phase I Resource Investigation
Organization (Grantee): Pope Soil and Water Conservation District
Project start date: August 29, 2013 Project end date: June 30, 2016 Report submittal date: 10/19/16
Grantee contact name: Holly Kovarik Title: Manager
Address: 1680 Franklin Street North
City: Glenwood State: MN Zip: 56334
Phone number: 320-634-5327 Fax: NA E-mail: Holly.kovarik@mn.nacdnet.net
Basin (Red, Minnesota, St. Croix, etc.)
/ Watershed & 8 digit HUC:: Minnesota/Chippewa River/07020005 County: Pope

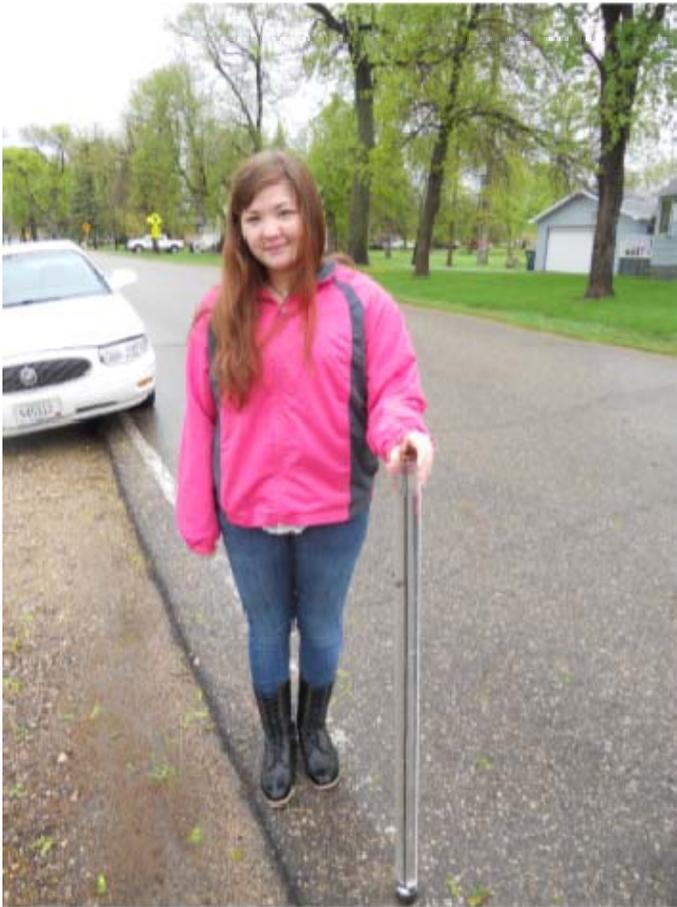
Above: Sample taken with Secchi Tube by SWCD Intern at one of the 9 sites monitored under this program.

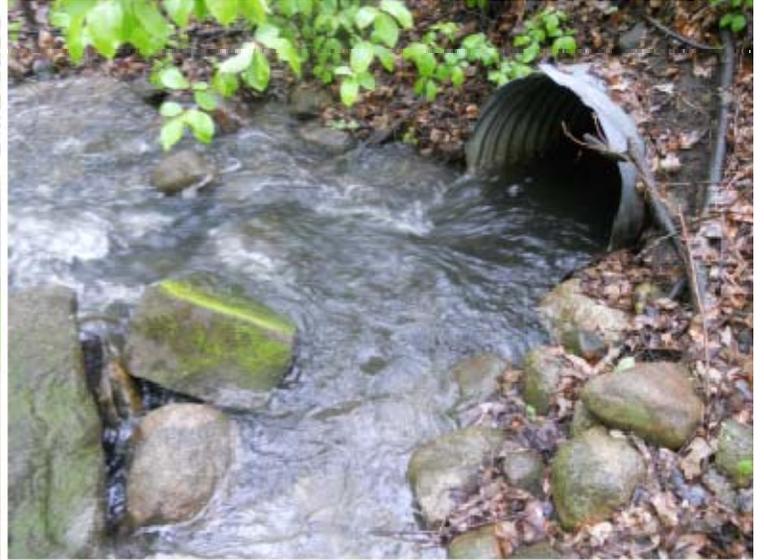
Pictured top right: A picture of one of the locations samples were taken.

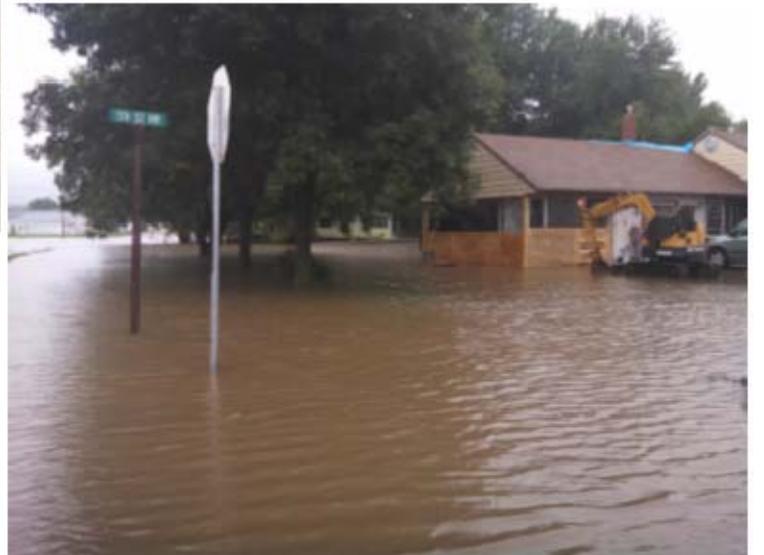
Pictured bottom right: Flooding in the City of Glenwood and resource concern for water quality. The Chippewa River Watershed monitored this area at a location just to the west of where this photo was taken.

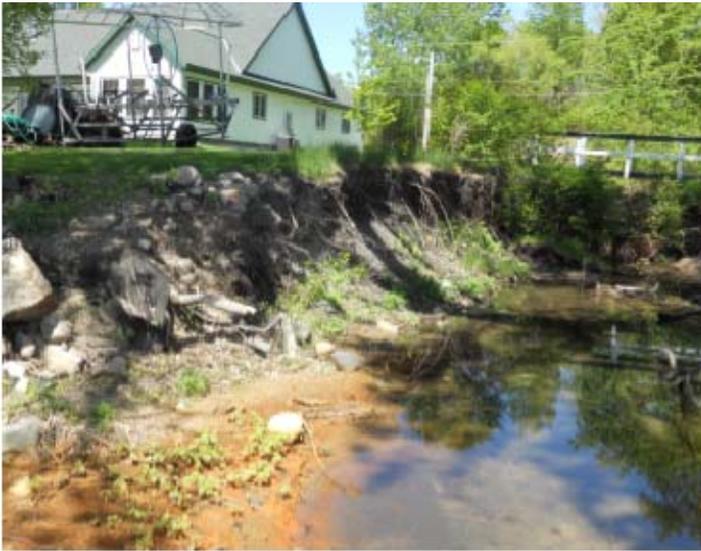
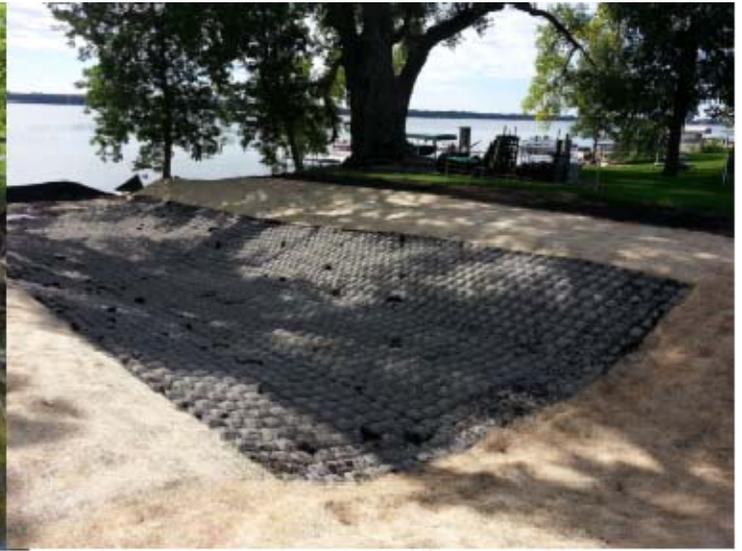
Above: Erosion issue on North side of Lake Minnewaska before and after construction of lined waterway.

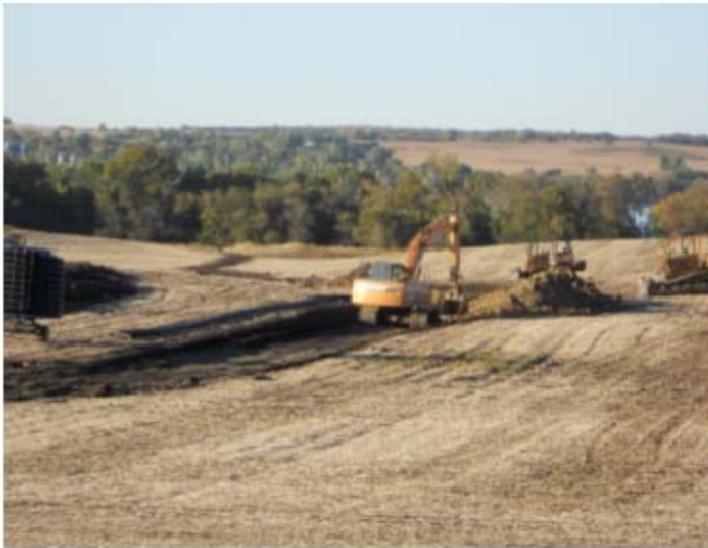
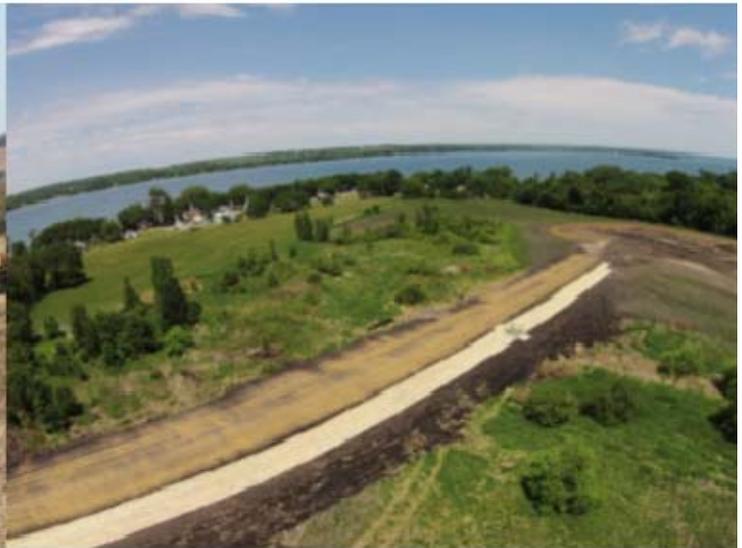
Above: Pictures of BMPs installed under Clean Water Funding project but focus narrowed due to MPCA monitoring efforts from this project.

Sub Task 1: There were 14 water and sediment control basins, 1 grassed waterway, and a grade stabilization structure project installed in the direct subwatershed to Lake Minnewaska utilizing the Terrain Analysis tool to target the optimum locations for implementation. Included is a map and fact sheet of some of the projects that were completed. They were all surveyed in October-November 2014 and technical staff are working on completing designs. These sites have been funded through NRCS EQIP funding or through the Pope SWCD BWSR Clean Water Fund Projects and Practices grant from 2014 and a new one recently received in 2015 for this project area. We are coordinating the implementation of the remaining projects in this subwatershed in the fall of 2015.

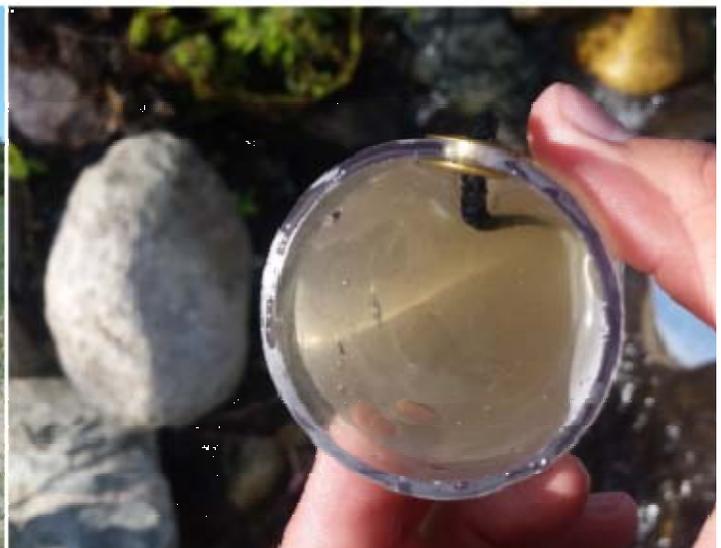
Above: Educational tour with County Commissioners conducted and a picture of secchi tube during monitoring.

- Sub Task 1: Four citizen monitors were contacted by staff and materials including secchi tubes were sent to the Citizen Monitors to complete the work each season 2014, 2015, and 2016. The citizen monitors/SWCD staff submitted their data to Pope SWCD staff and this information was entered into the proper format by the SWCD staff and submitted to meet the November 1 deadline.
- SubTask 2: Pope SWCD located sampling sites through maps and site visits and marked using ArcGIS all sites on a map. This map and GPS locations were sent to MPCA to be established in EQUIS and the Citizen Monitoring program.
- Sub Task 3: Staff completed a packet for each citizen monitor on the location of the site and conducted a site visit with the citizen monitor to ensure that they knew how to complete the sampling properly and had the correct location for the sampling.
