## POPE SOIL & WATER

## CITY OF GLENWOOD RAVINE REPAIR PROJECT

**Ravine Repair**

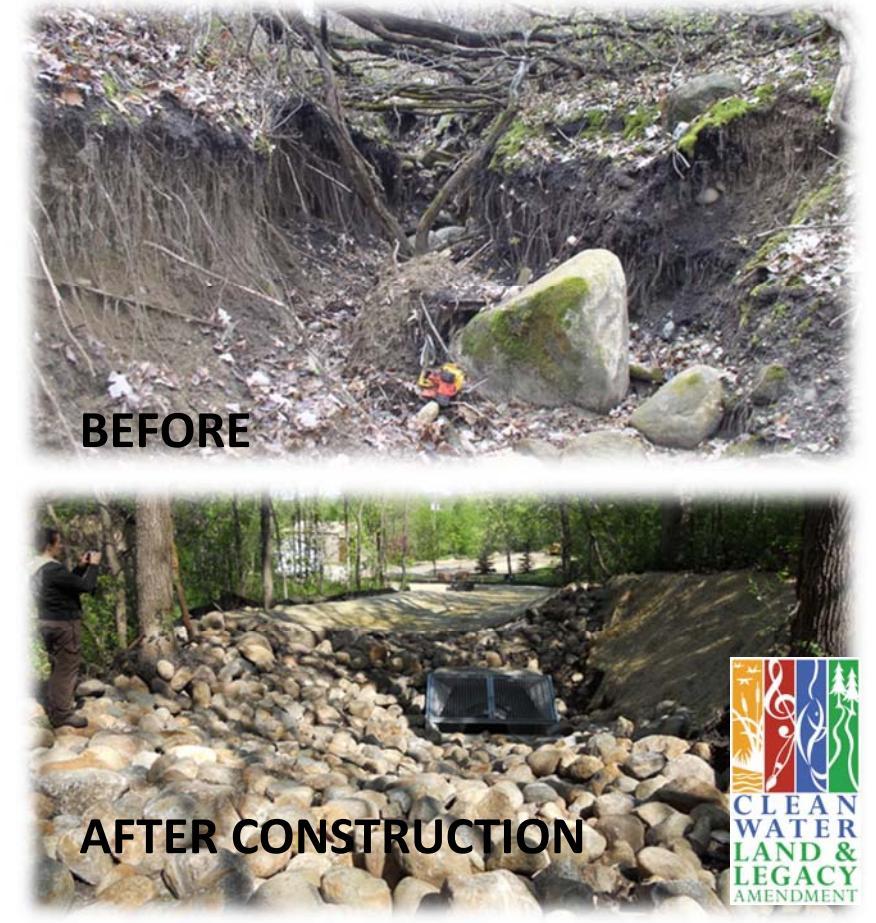
3 rock check dams, inlet structure, underground water line with line access, chimneys, control structure, culverts, and rip rap

The highest priority projects were located in the Dairyland Basin. This covers 462 acres with only 26% of that within the City and has 82.9 acres of impervious surfaces and 379.1 acres of pervious surface. Ravines were found originating from highway 55 and have been the worst in the last 10 years. The ravines measure 20' to 30' deep in some places. The project repaired the ravine using 3 check dams, an inlet structure, underground water lines, a control structure, and rock rip rap.
